Your Inspection Report

120 Rands Road
Ajax, ON

INSPECTION DATE:
Saturday, November 15, 2008

Report No. 11831, v.2

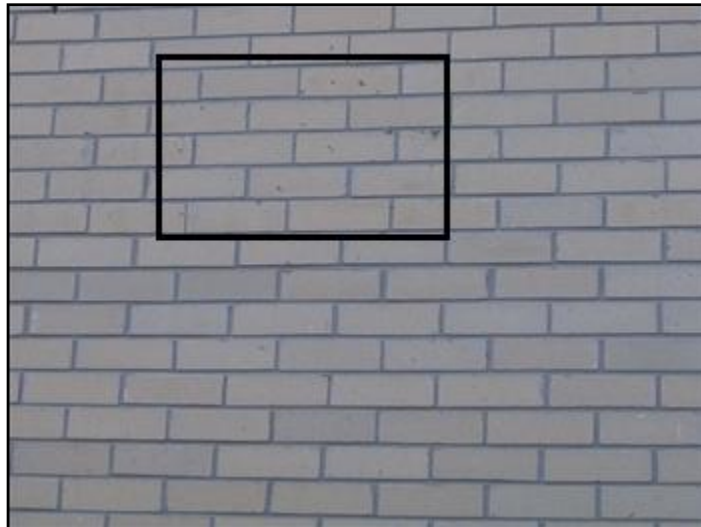
Condition: • [Mortar splatters and stains on exterior masonry](#)

Location: Right Side

3. Mortar splatters

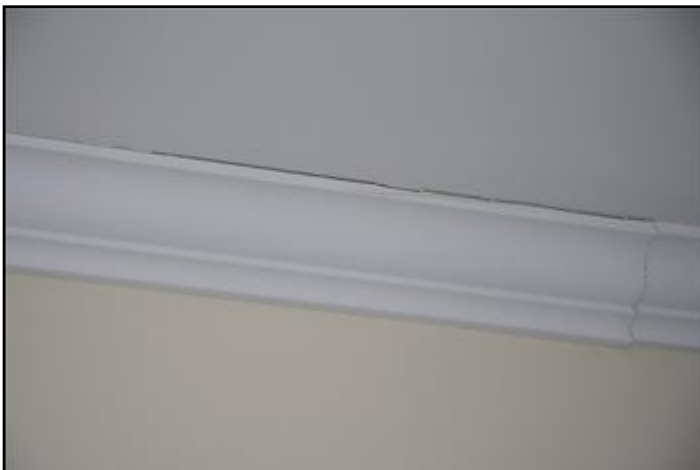
Condition: • [Interior trim is split](#)

Location: Living Room

4. Living room crown moulding - east wall

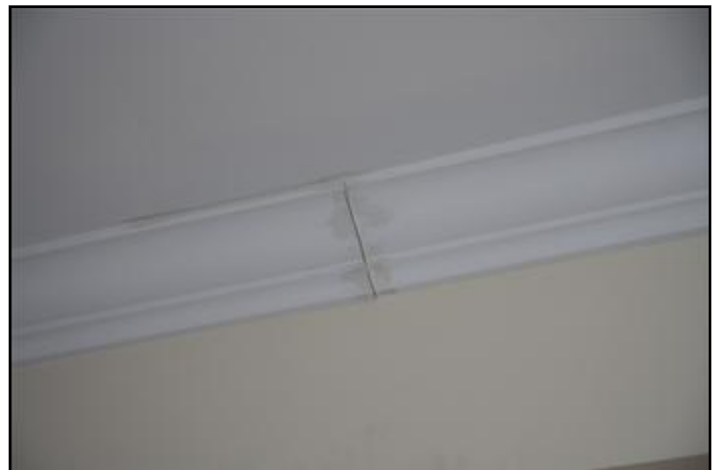
5. Living room crown moulding - west wall

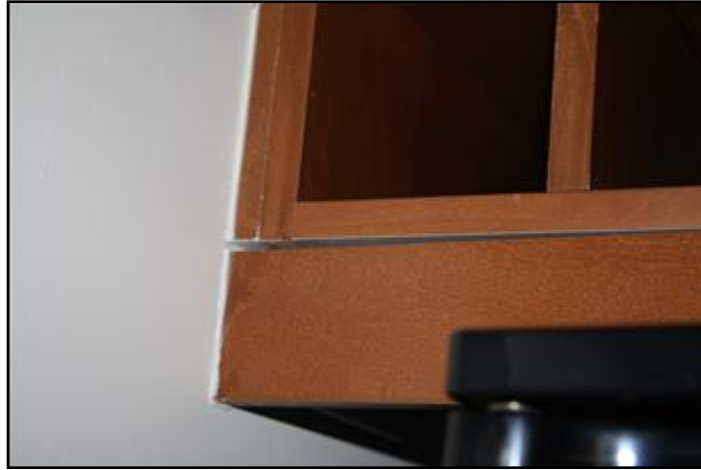
Condition: • [Gap between cabinets and ceilings or walls](#)

Location: Kitchen

6. Upper cabinet trim

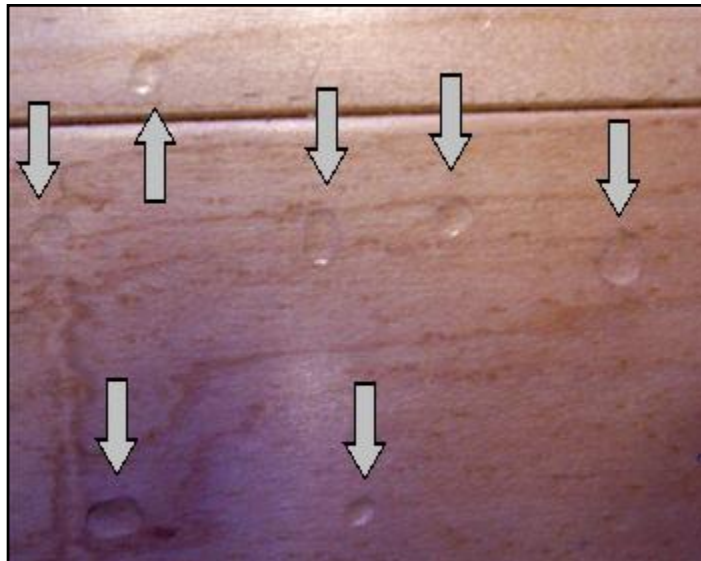
Condition: • Numerous dents in wood flooring

Location: Second Floor Hall

7. Floor near washroom
